Discovery STS-114

SSME Flight Readiness Review

June 29-30, 2005

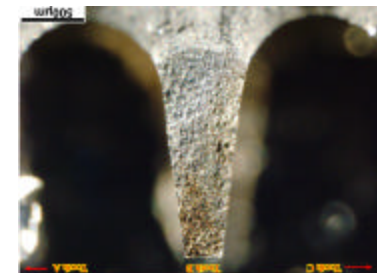
HPOTP 8016R4 Outboard Seal (-011) Crack Indications

- Multiple seals found with radial cracks in 4-tooth seal during overhaul and recycle operations
 - 3 flight configuration seals
 - Severity varies from single crack in one tooth to multiple cracks in all four teeth
 - 2 non-flight, early development configuration seals
 - Multiple cracks in all four teeth
- Single occurrence of circumferential web cracking
 - Intermittent, 360 degrees, one location with through crack
- Cracking had no impact on seal functionality or engine operation
- No FOD generated

Radial Tooth Crack

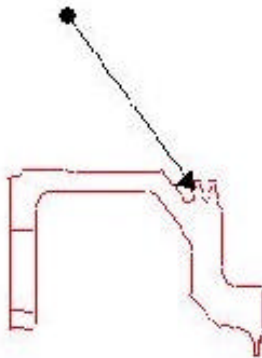
-072 Seal Pump Side Tooth Crack Map

- Cracks and material loss found in knife edge 2-tooth seal during scheduled overhaul of 5 flight HPOTPs
 - Pump side tooth cracking and material loss on 4 of 5 seals
 - 3 of 5 had turbine side tooth cracking also (no material loss)
 - Pump side tooth cracking only (no material loss) on one seal
- Cracking and material loss had no significant impact on seal functionality or engine operation

Area of Indications

— Crack Region

Crack patterns show loss of entire tooth is unlikely
